**CAPITOL PLANNING COMMISSION
VERTICAL INFRASTRUCTURE ADVISORY COMMITTEE MEETING
January 17, 2007**

Historical Building Planter Beds: Waiting decision based on budget

IV DISCUSSION OF FINDINGS

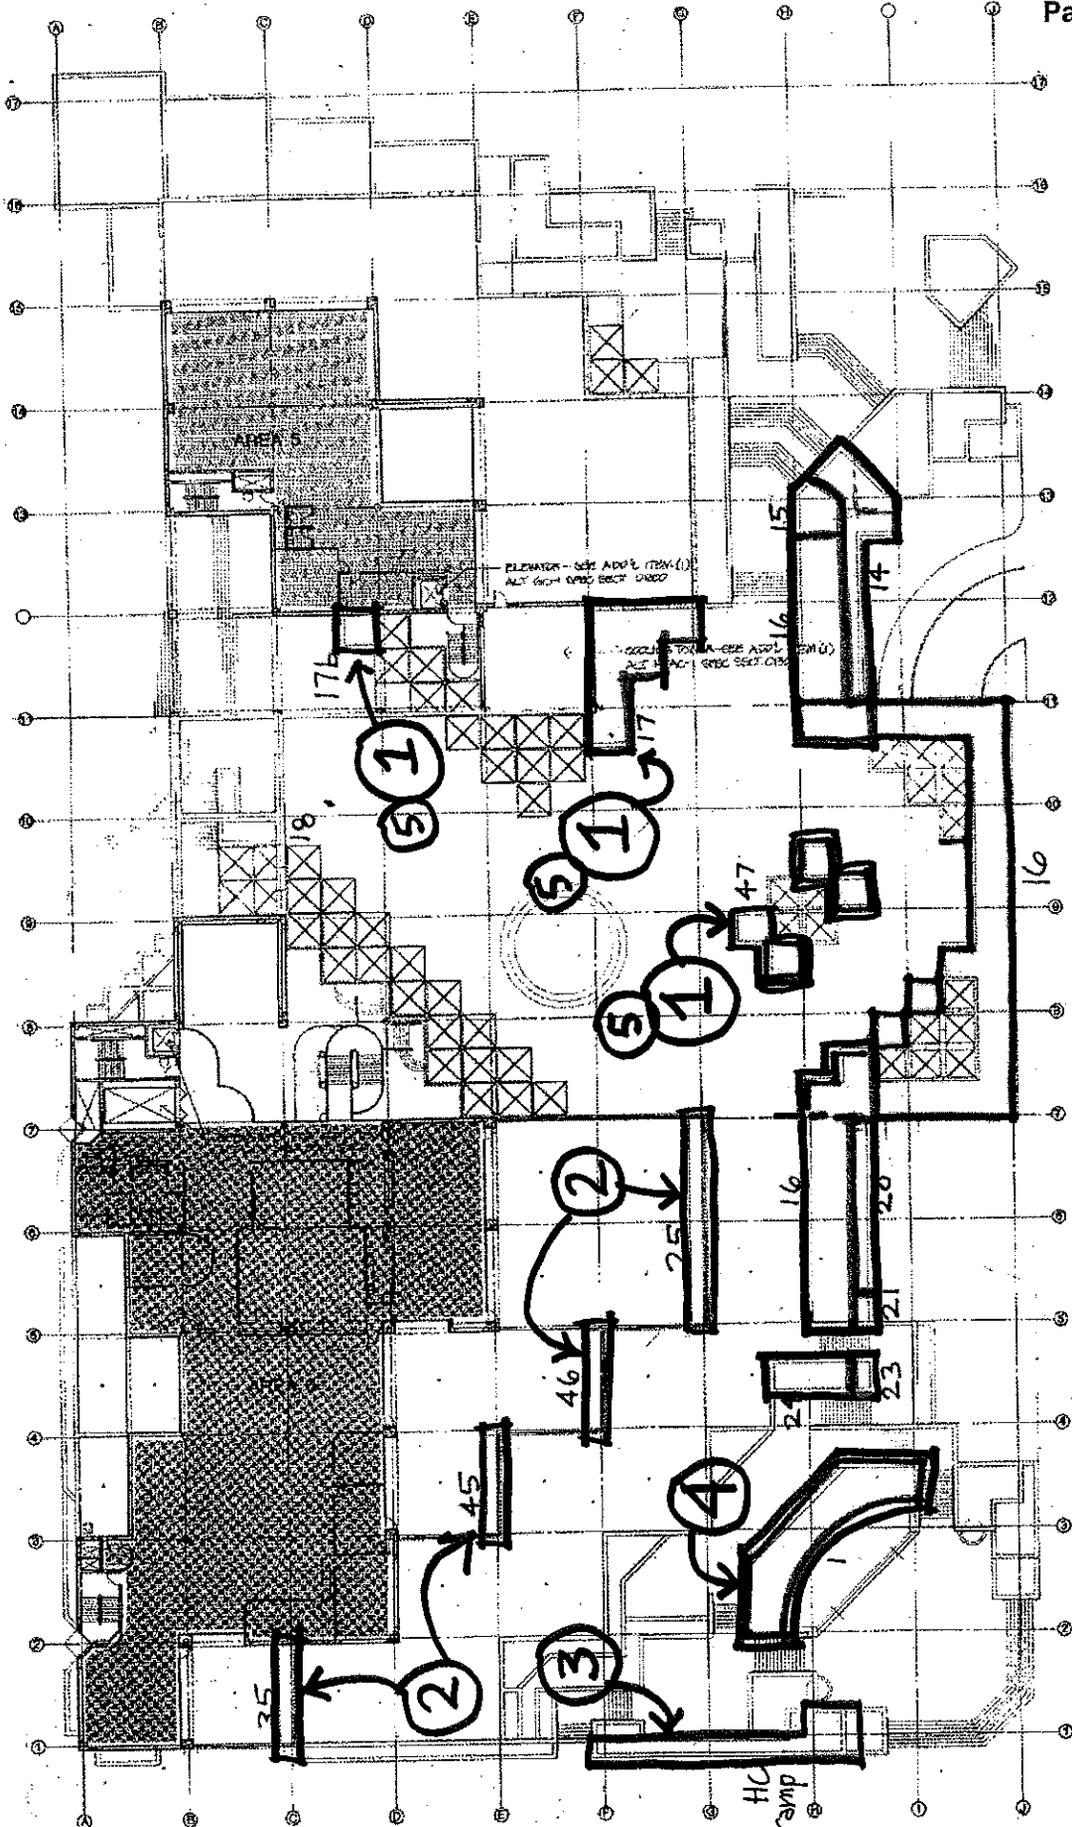
PLANTER BED LOCATIONS AND ALTERNATES

LEVEL THREE

SCALE: 1" = 20'

Estimate of All Work Associated With Planter Beds Over Occupied Areas (15 total)
Removal and Replacement of plant material not included
